**U.S. ENVIRONMENTAL PROTECTION AGENCY
POLLUTION/SITUATION REPORT
2015 Gold King Mine Release SITREP**

Subject: SITREP #3
Gold King Mine Release

San Juan County, Colorado
Latitude: 37.8945 Longitude: -107.6384

Date: 08/11/2015

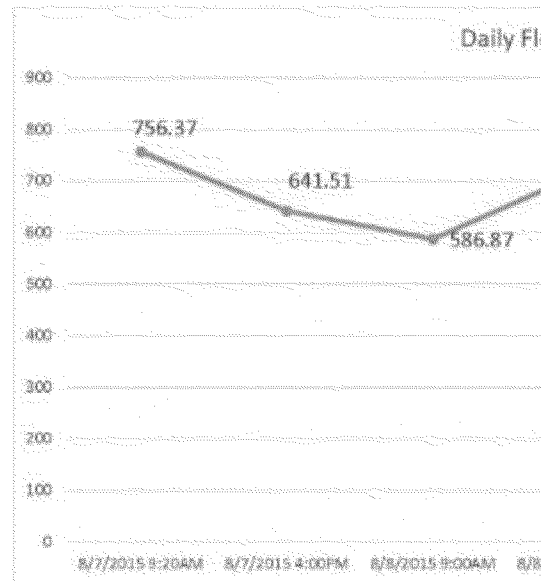
The EPA continues to operate four treatment and sedimentation ponds at

the mine site and which are treating water by lowering acidity levels and removing dissolved metals. Flow from the mine Tuesday morning is shown in the following chart.

Treated water from the last treatment pond is discharging into Cement Creek at levels cleaner (higher pH and lower levels of metals) than pre-event, background conditions in the creek. Over the next several days, the EPA will make upgrades to the system to ensure its continued operation.
